Manhole Inspection Summary

Manhole # S23A__014MH

Insp Date: **7/25/07 2:05 PM**

Location Address: **716 MOUNT-GIMORE**

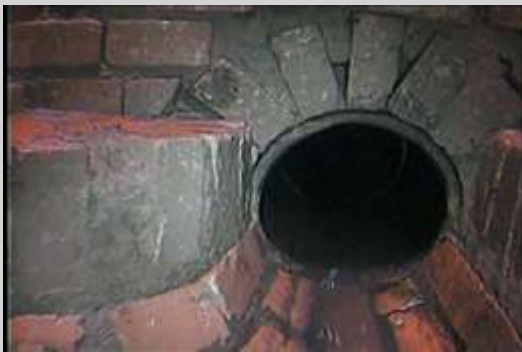
12 O'Clock Outflow

8 in. Circular Gravity Sewer
Pipe Out @ 12 O'Clock

Pipe Height: **7.2** (in.) Rod and Bar (Angled)
Pipe Material: **Clay** ☐ Pipe Lined
Invert Depth: **10.99** (ft.) Flow Characteristics: **Slow**
Deposits: ☒ None ☐ Mud ☐ Sludge ☐ Debris ☐ Grease
Silt Depth: (in.) Deposits Extent:
Infiltration: **None** Pipe Seal Cond: **Sound**

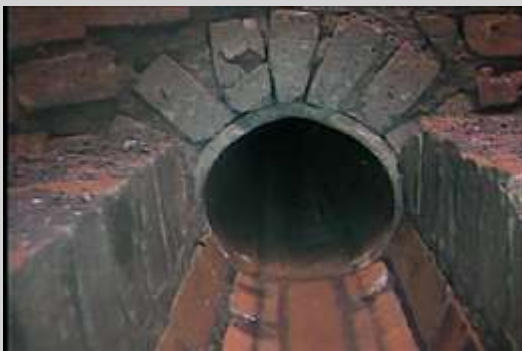
6 O'Clock Inflow

8 in. Circular Gravity Sewer
Pipe In @ 6 O'Clock

Pipe Height: **7.2** (in.) Rod and Bar (Angled)
Pipe Material: **Clay** ☐ Pipe Lined
Invert Depth: **10.96** (ft.) Flow Characteristics: **Slow**
Deposits: ☒ None ☐ Mud ☐ Sludge ☐ Debris ☐ Grease
Silt Depth: (in.) Deposits Extent:
Infiltration: **None** Pipe Seal Cond: **Sound**
